approach

OCTOBER 1971 THE NAVAL AVIATION SAFETY REVIEW

Wheels-Up Landings,

ON PURPOSE.

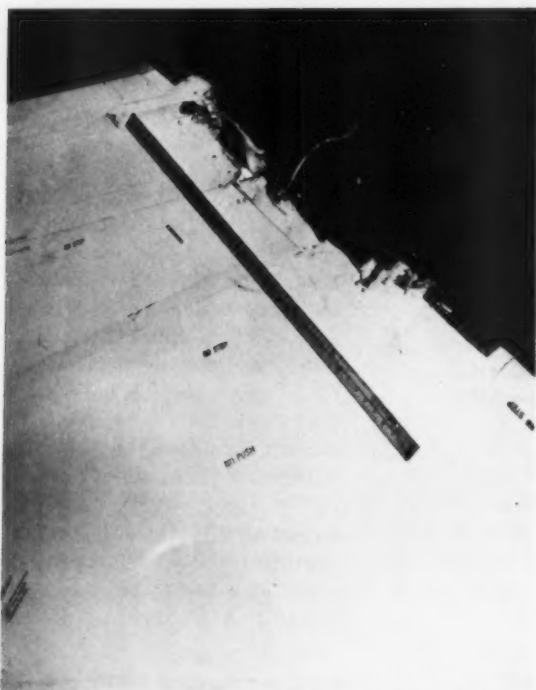
View of the damaged F-8J starboard wingtip.

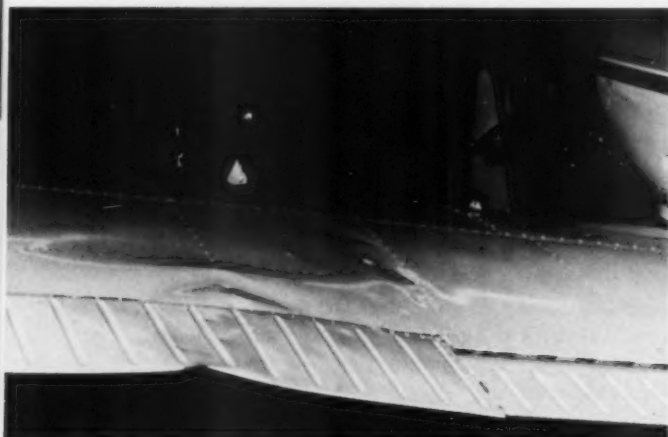
Damaged area showing the initial contact point on the Cherokee's port wing.

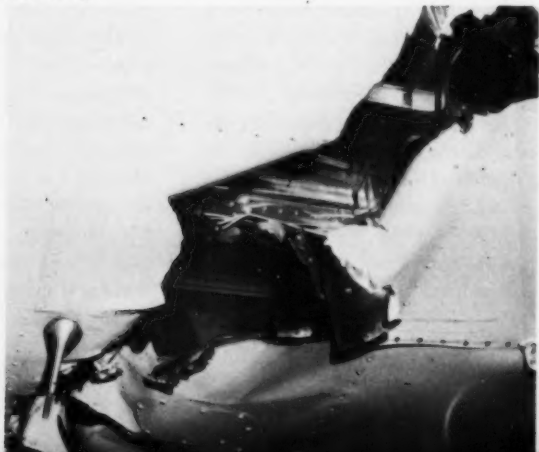
Another view of the resultant damage to the *Cherokee's* port wing.
